CUSTOMER TECHNICAL MEMO # 208

Subject: CSD INTERLOCK ANTI-LIFT BLOCK

Date: 25-06-2014

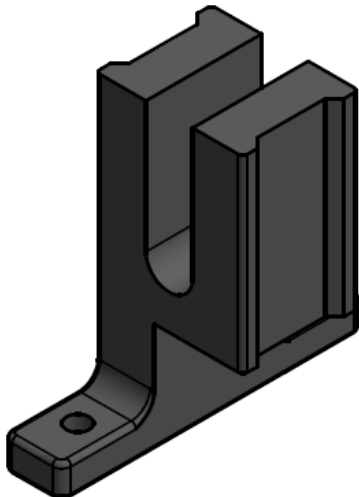
New Item

We have improved the design of this product so that it is now installed onsite to avoid the possibility of damaging the fixing feet during transport.

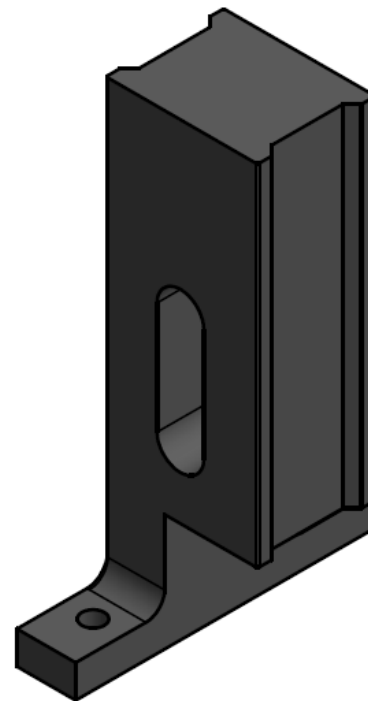
Old Item

We have received feedback from our customers that the original design of our CSD INTERLOCK ANTI-LIFT BLOCK was prone to damage of the fixing feet during transport to the installation site.
